29 East Hanover Street
(Commercial Building)
Trenton
Mercer County
New Jersey

HABS No. NJ-973

ARCHITECTURAL DATA FORM

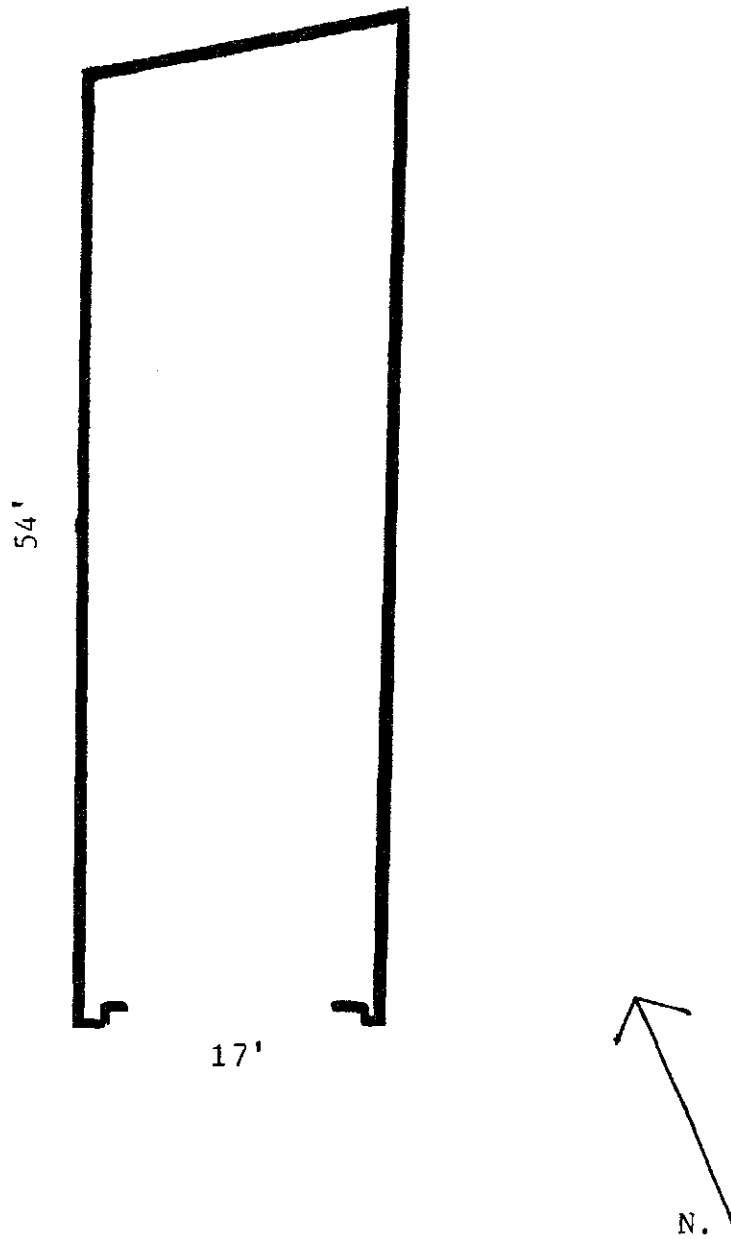
Floor Plan

MATERIAL OF CONSTRUCTION (INCLUDE STRUCTURAL SYSTEMS) Masonry load-bearing walls with wooden beams and interior partitions.		
SHAPE AND DIMENSIONS OF STRUCTURE (SKETCHED FLOOR PLANS ON SEPARATE PAGES ARE ACCEPTABLE) Rectangular, 17' x 54'. Flat-roofed 3-story building.		
EXTERIOR FEATURES OF NOTE Dark yellow brick facade with wide, deeply incised joints with dark gray mortar. Common bond brickwork is highlighted by a soldier course emphasizing the quadrapartite bay. 6/1 wooden sash are topped by operable metal transoms. Cornice has pyramidal finials.		
INTERIOR FEATURES OF NOTE (DESCRIBE FLOOR PLANS, IF NOT SKETCHED) Interior was inaccessible at the time of recording. Glimpses were achieved through holes in the walls of the adjoining building at 27 E. Hanover, and indicated that sheetrock and linoleum tile have replaced any original features of interest.		
MAJOR ALTERATIONS AND ADDITIONS WITH DATES This was built as one of a trio of commercial buildings about 1881, but it was subdivided from its neighbors (25-27 East Hanover St.) late in that same year. It was extensively remodelled about 1925 to house a cafe, a use it retained into the 1970s.
